**FIGURE 3-1**  
**DIELDRIN DISTRIBUTION ALONG NORTH BANK**  
**OF CYPRESS CREEK CHANNEL**

**FIGURE 3-2**  
**DIELDRIN DISTRIBUTION ALONG SOUTH BANK**  
**OF CYPRESS CREEK CHANNEL**

**FIGURE 3-3**  
**DIELDRIN DISTRIBUTION BY CONCENTRATION RANKING**

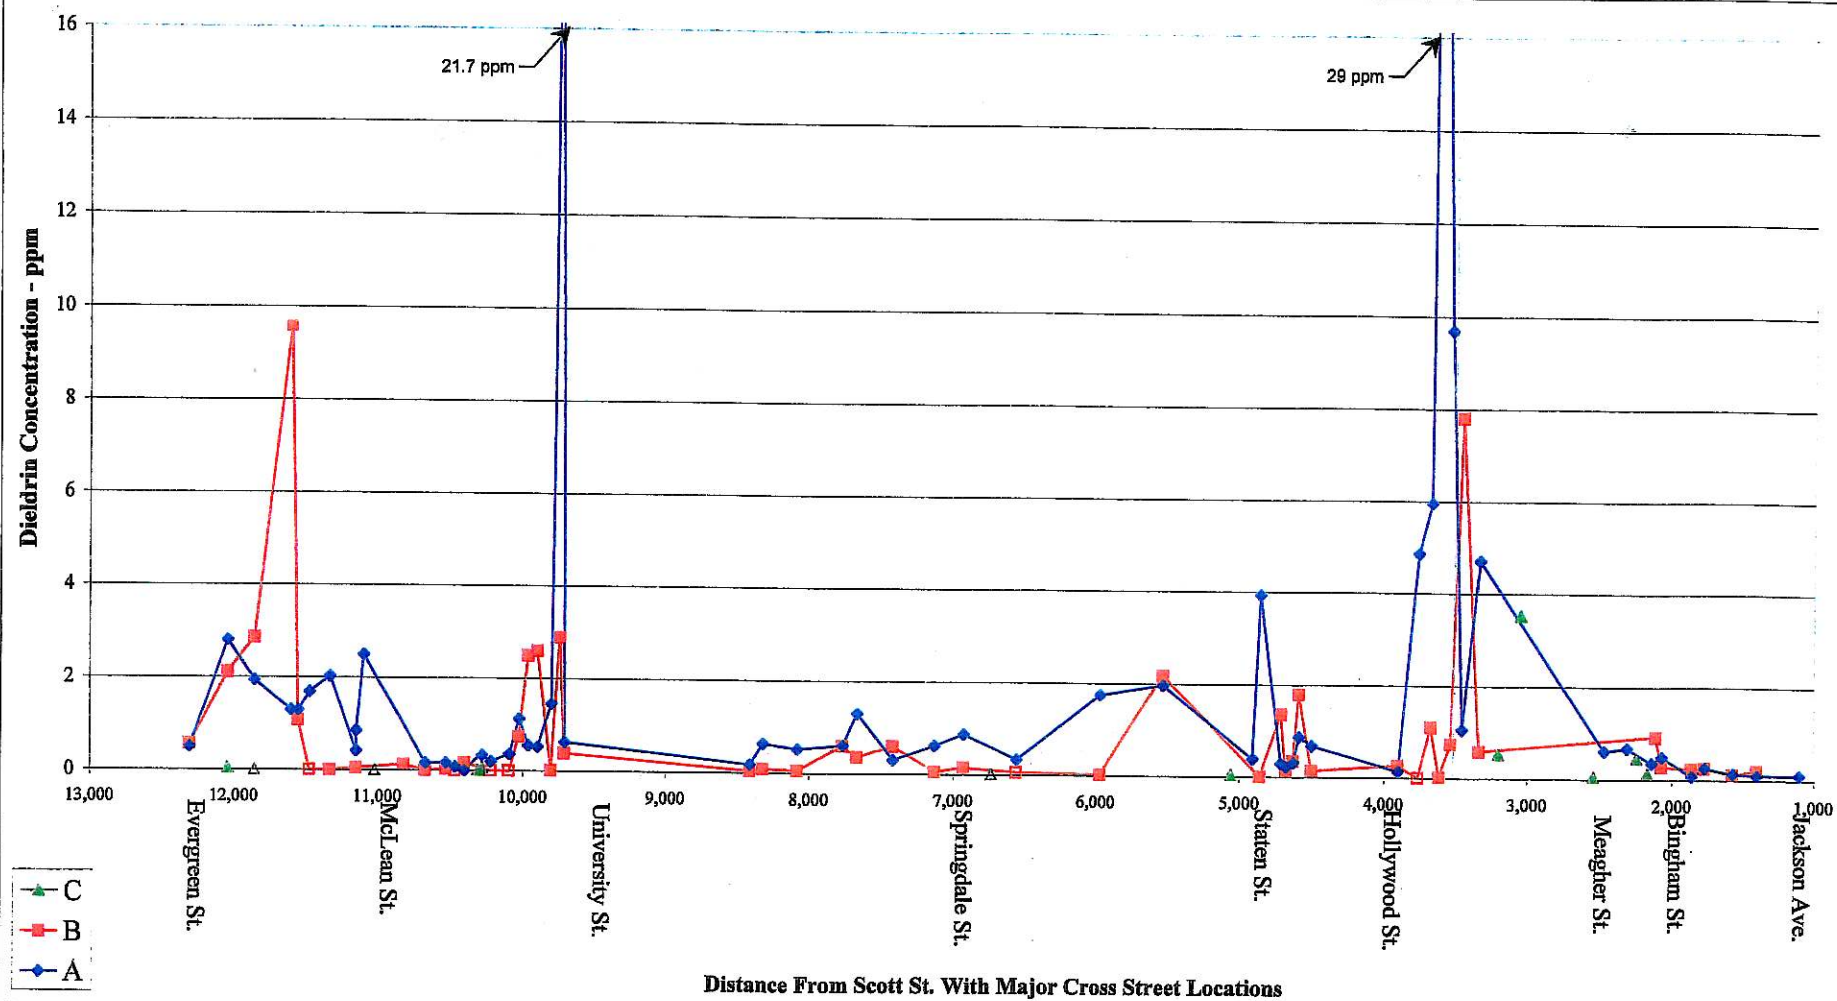
Notes:  
 A is within construction easement  
 B is outside of construction easement  
 C is remote from Creek and not related to construction easement  
 Open marker denotes non-detect concentration  
 All results reported on a dry weight basis
